Protection of Jeita Spring

ADVISORY SERVICE DOCUMENT NO. 2

**Locating the Source of the Turbidity Peaks
Occurring in April - June 2012 in the Dbayeh
Drinking Water Treatment Plant**

**Raifoun
June 2012**

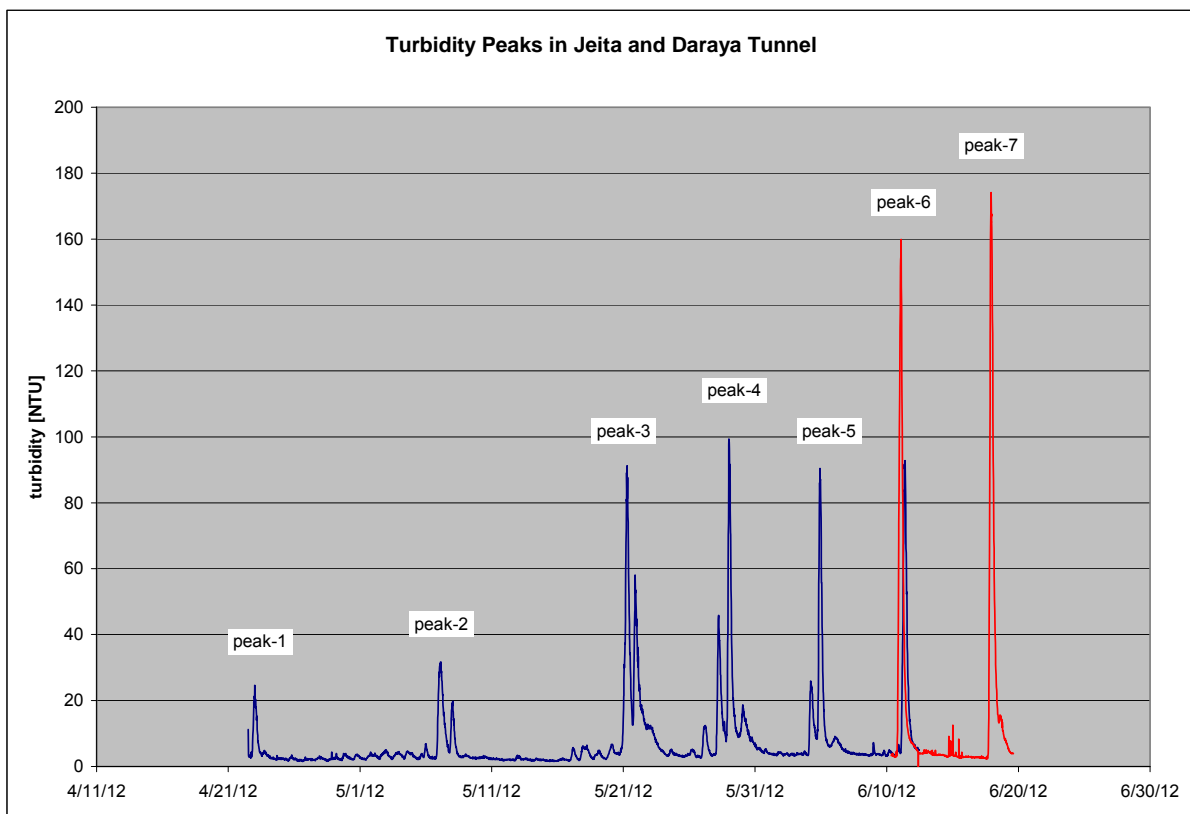
Six individual turbidity peaks were observed between 23 April and 11 June 2012 (Figure 1). These events were monitored by the BGR project using multiparameter probes (InSituTroll 9500) in Jeita (E 35.648579°, N 33.946155°) and in the Daraya Tunnel (siphon terminale or Jeita 140; E 35.690799°, N 33.951422°).

Figure 1: Turbidity Monitored in Jeita (blue) and Daraya Tunnel (red)

The comparison of all seven turbidity events shows that there were mostly two separate peaks with a time separation of almost 24 h. The first peak typically reached Jeita monitoring station on Monday between 0:00 and 09:00, the second peak between Monday 22:00 and Tuesday 01:00. The reason for this similar spacing in time and magnitude is believed to be an operational routine. It is assumed that the sand is separated from fine material (silt, clay) by washing. Water may be taken from the irrigation canal from Naber al Labbane (SAADEH et al., 2011).

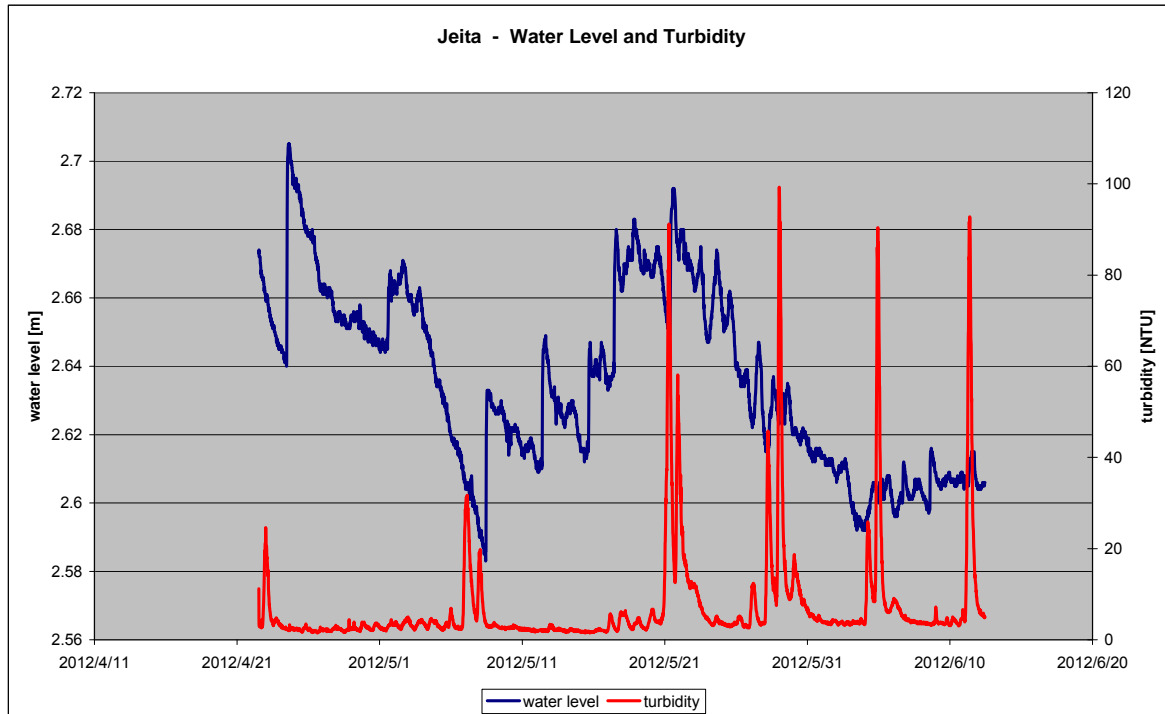
Figure 2: Correlation of Turbidity (red) and Water Level (blue) Monitored in Jeita

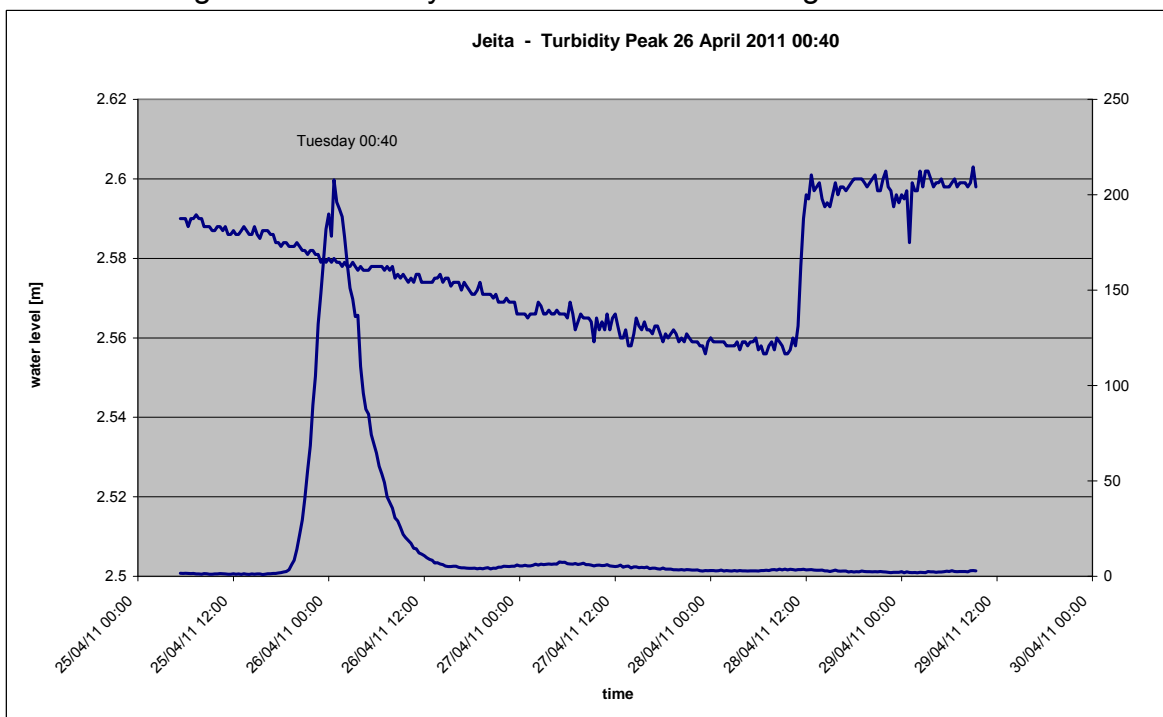
Figure 11: Turbidity Peak on 26 April 2011 in Jeita

Similar but fewer and less regular events occurred in April 2011 (Figure 11) and June 2011 (Figure 12).

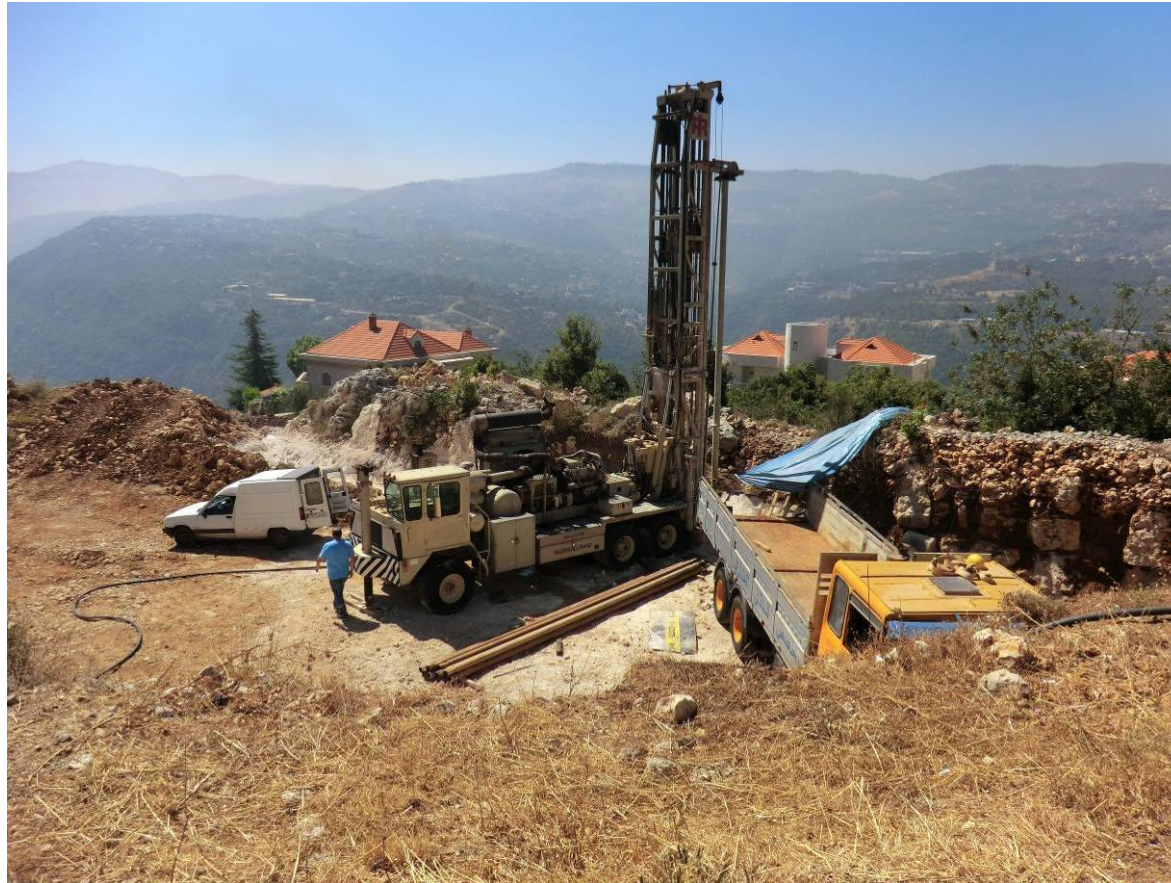
Figure 14: Drilling of Joseph Nassar Water Well in Ballouneh

- (1) borehole Joseph Nassar in Ballouneh (Figures 14, 15)
(E 35.680419°, N 33.950730°, ~ 675 m asl)
drilling to groundwater level, at 450 m on 15 June 2012
drilling started approx. 20 days earlier using rotary rig with drilling mud,
since 14 June 2012 percussion rig
continuous operation, weekly injection unlikely
ca. 960 m W of Daraya tunnel (downstream)

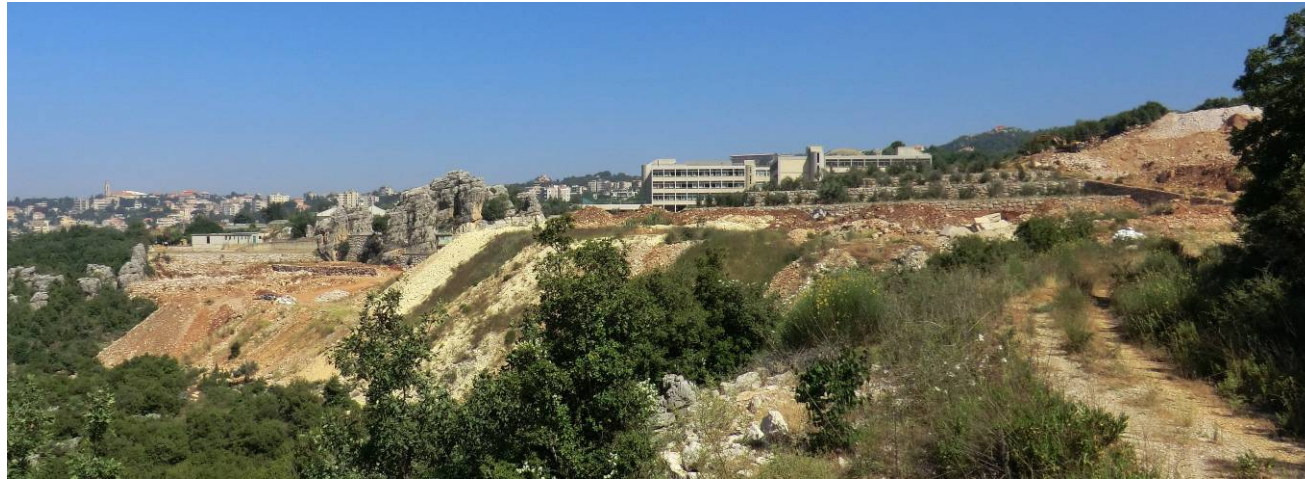
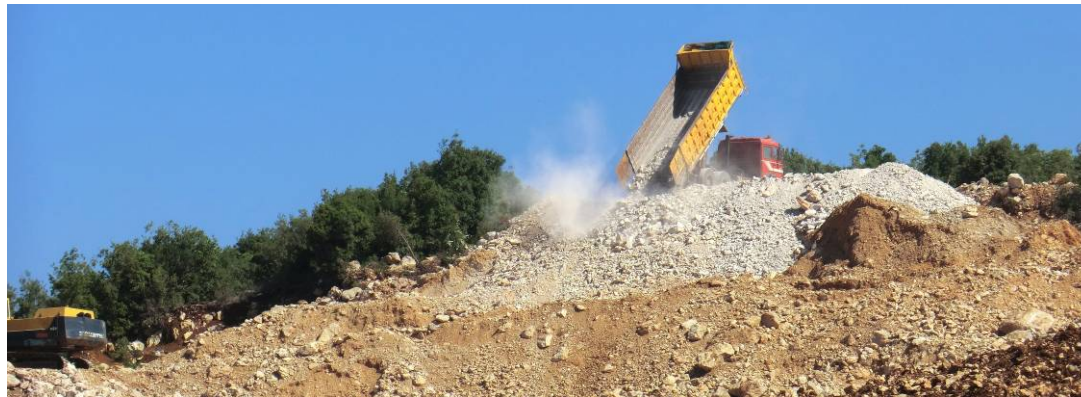
Figure 16: Construction Waste Dump at Mar Roukoz School

- (2) construction waste dump site next to Mar Roukoz school (Figures 16, 17)
(E 35.702113°, N 33.960792°, ~ 820 m asl)
continuous operation since many years, no water available for flushing,
weekly injection unlikely
ca. 1500 m NE of Daraya tunnel (upstream)

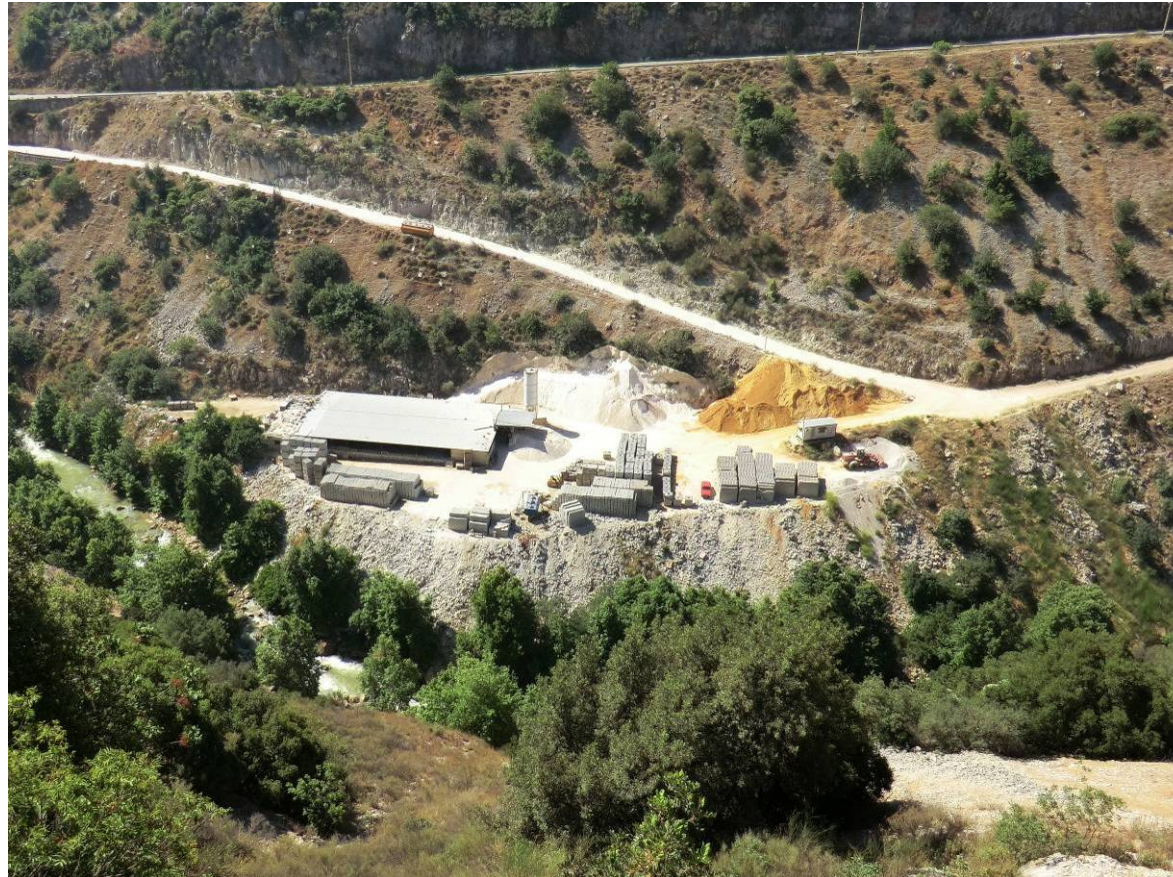
Figure 18: Cement Brick Factory in Lower Nahr es Salib

Figure 19: Potential Pollution Site (3): Cement Brick Factory in Lower Nahr es Salib

- (3) cement brick fabrication in lower Nahr es Salib (Figures 18, 19)
(E 35.702113°, N 33.960792°, ~ 555 m asl)
approx. 20 m from river, dumping into river observed
flushing with river
ca. 2500 m E of Daraya tunnel (upstream)

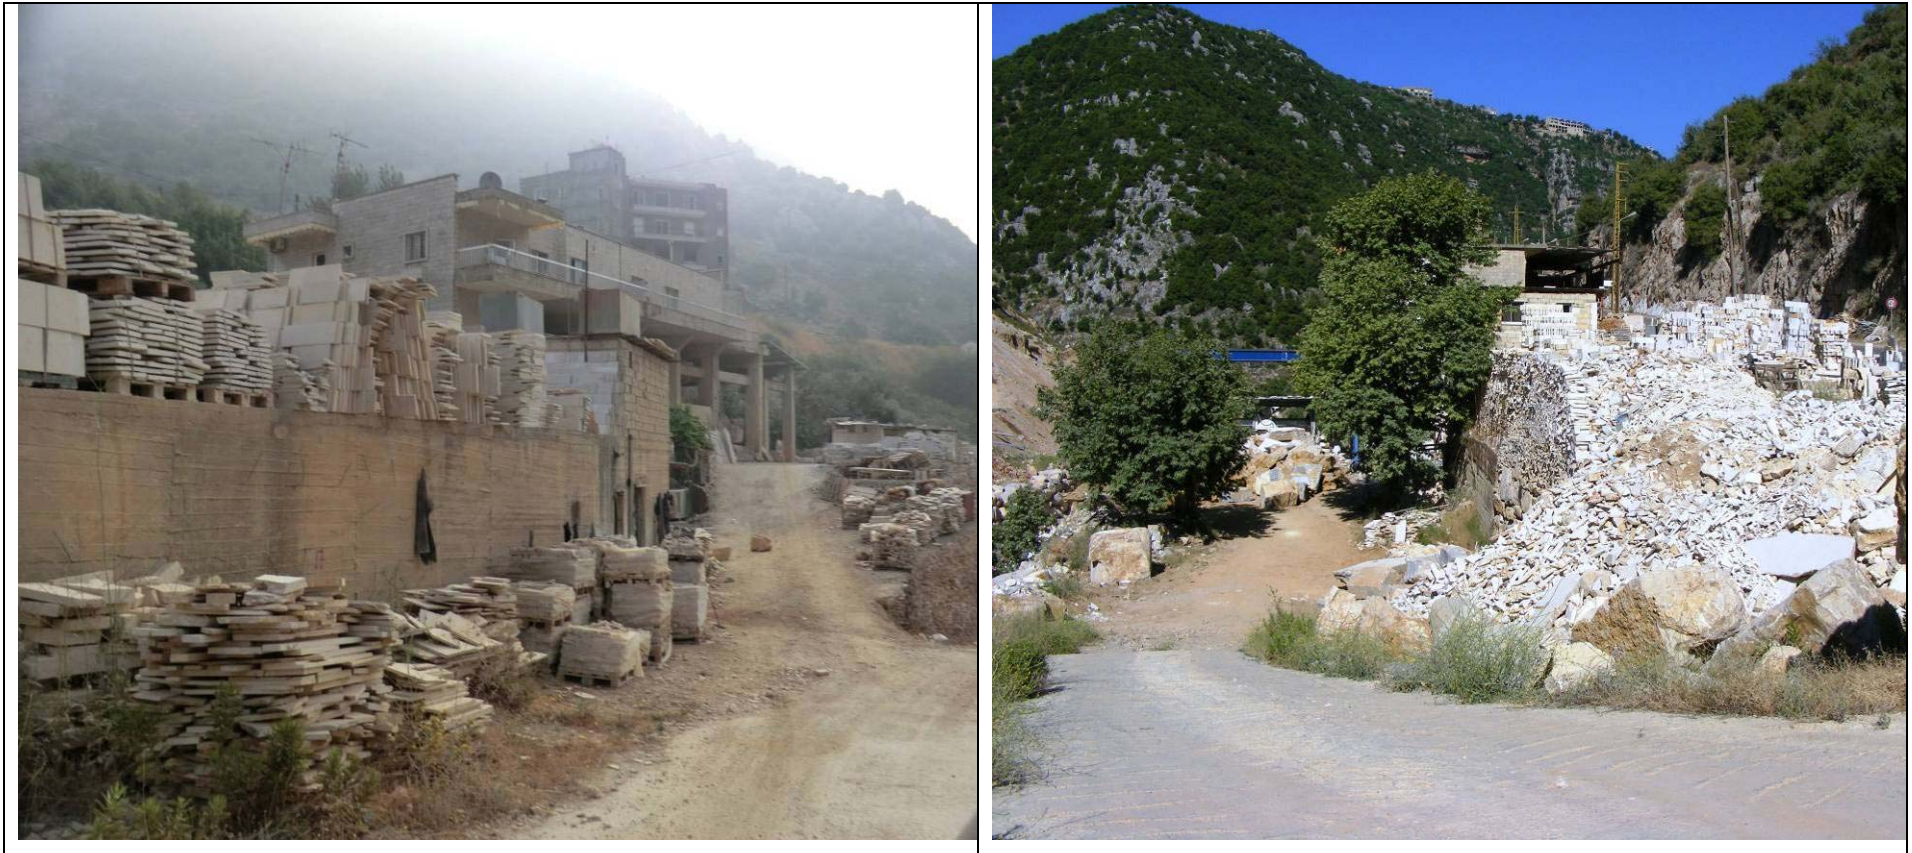
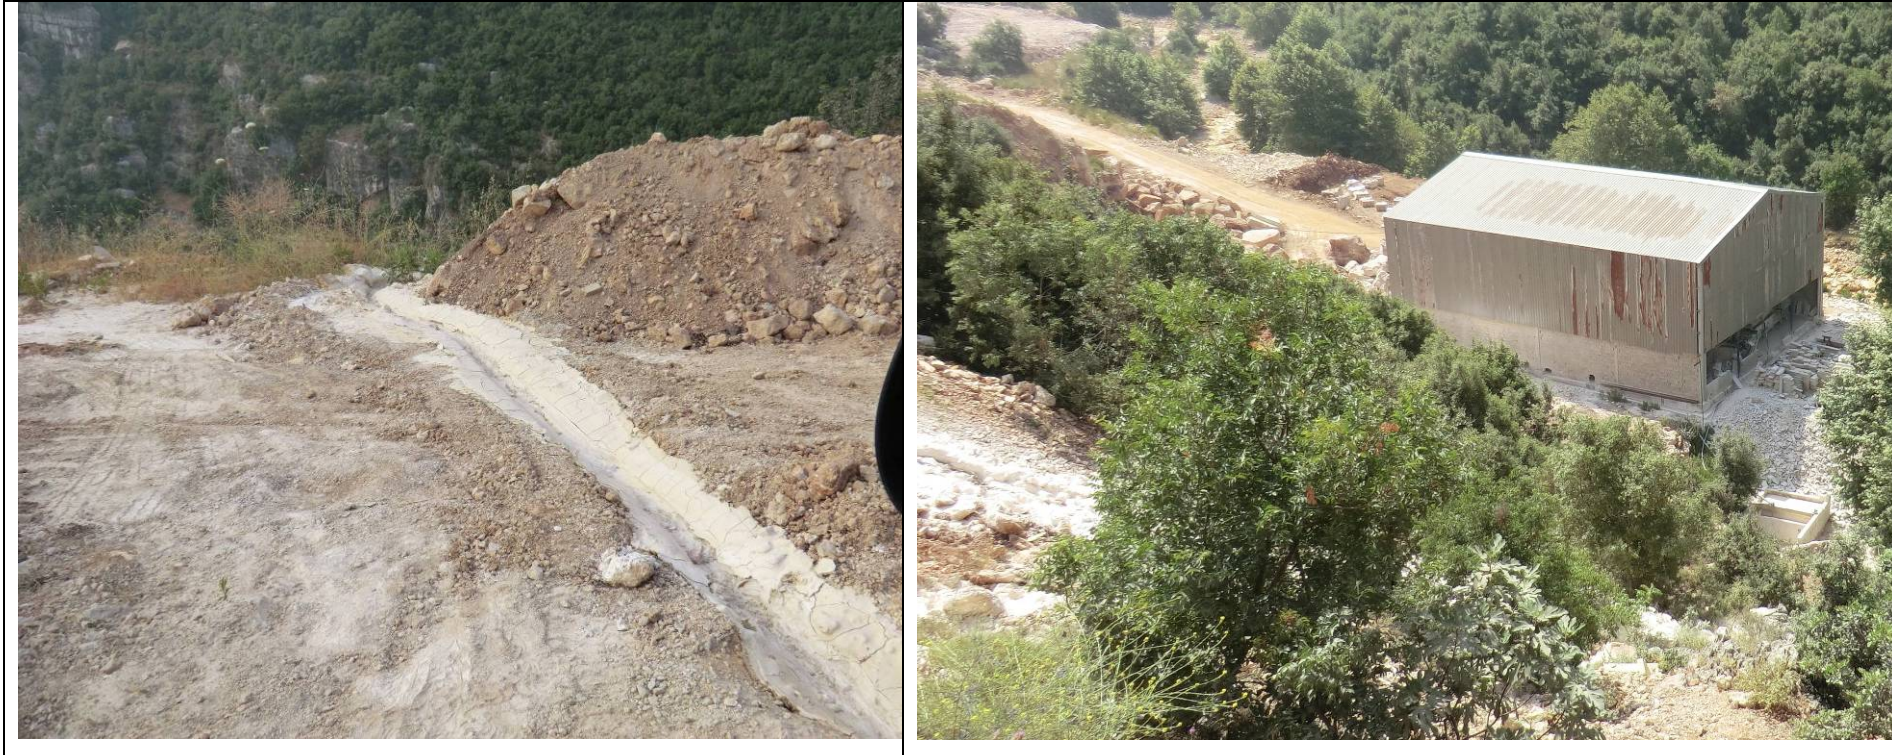
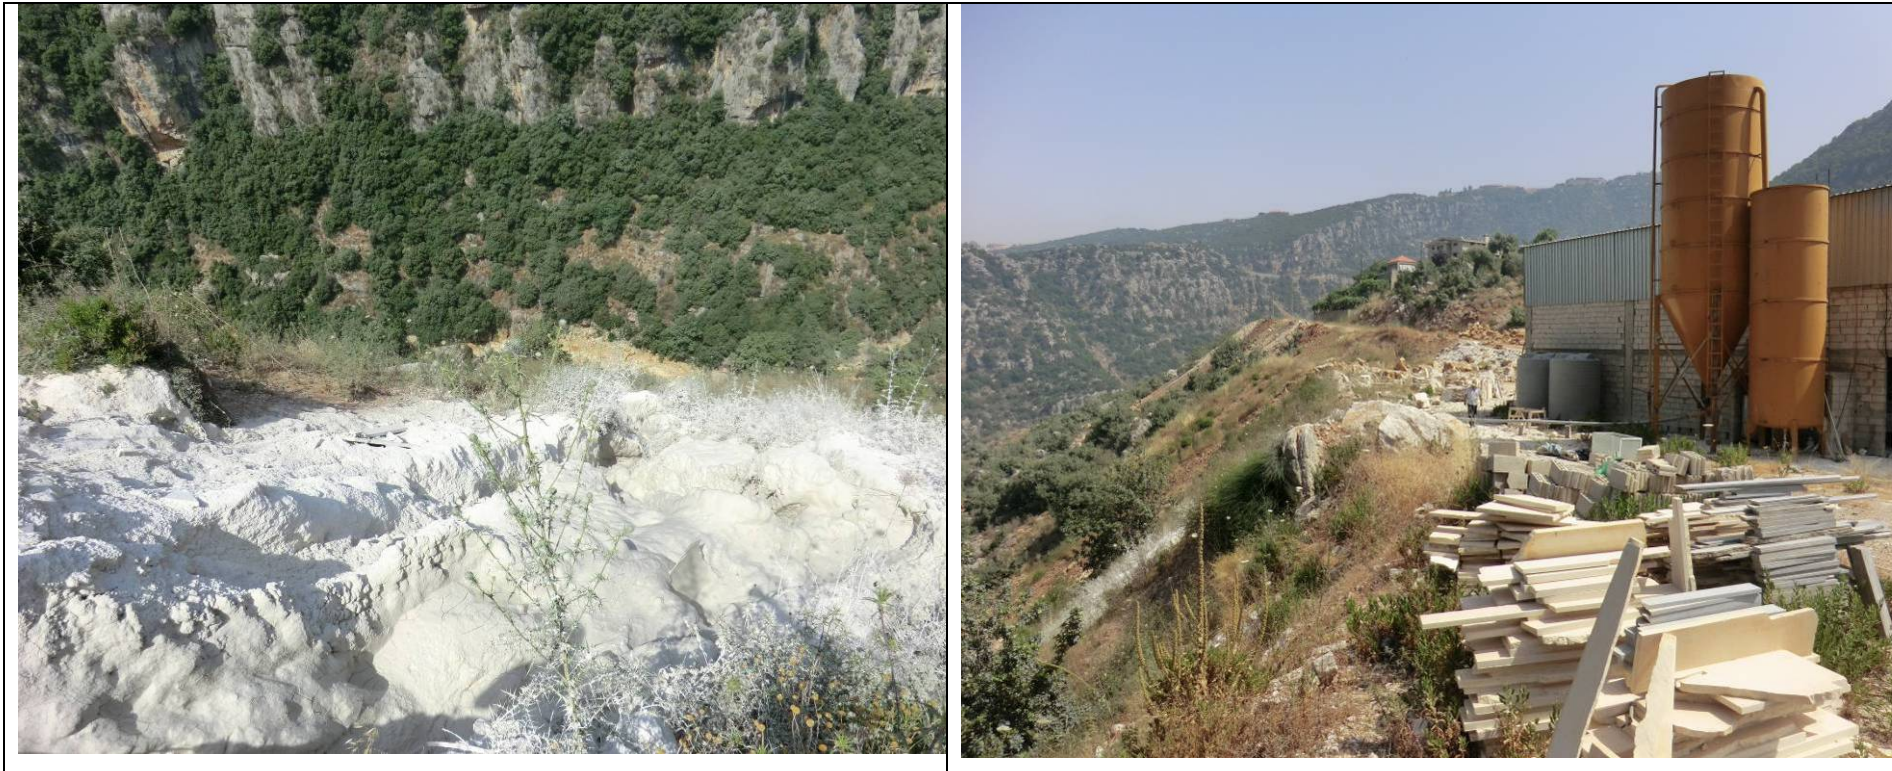
Figure 21: Decoration Stone Cutting Factories in Deir Chamra

Figure 22: Discharge of Limestone Sludge into Nahr es Hardoun from Decoration Stone Cutting Factories in Deir Chamra

Figure 23: Discharge of Limestone Sludge into Nahr es Hardoun from Decoration Stone Cutting Factories in Deir Chamra

Figure 24: Potential Pollution Site (5): Decoration Stone Cutting Factories in Deir Chamra

- (5) decoration stone cutting factories in Deir Chamra (Figures 21, 22, 23, 24)
(E 35.711043°, N 33.945585°, ~570 m asl)
approx. 100 m from river, dumping into river observed
flushing with river
flow in Nahr es Hardoun almost zero,
not part of Jeita groundwater catchment
ca. 2100 m E of Daraya tunnel (upstream)

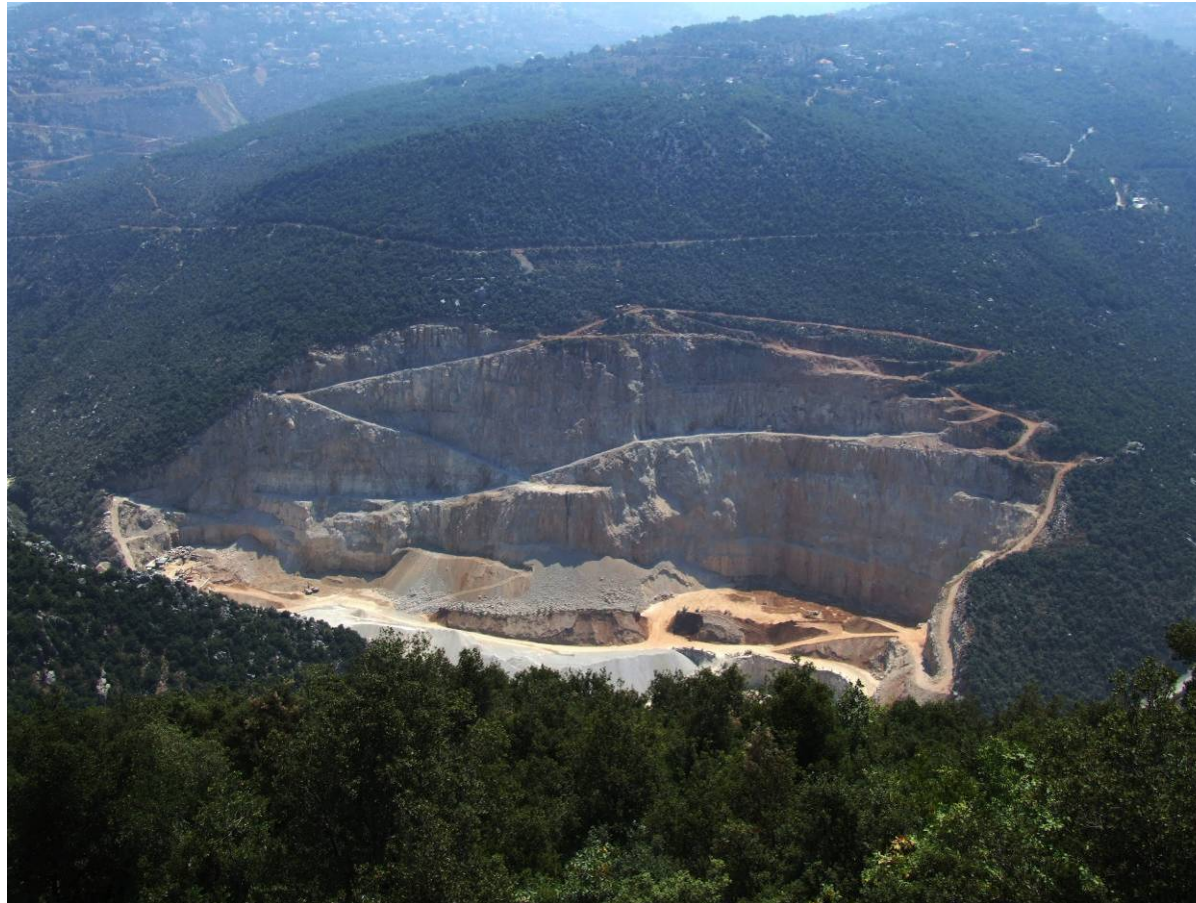
Figure 25: Limestone Quarry for Cement Production (ELKA) in Abou Mizane (08/2011)

- (6) ELKA cement limestone quarry in Abou Mizane (Figures 25, 26, 27)
(E 35.729925°, N 33.942568°, ~ 620 m asl)
directly at river, dumping into river likely
flow in Nahr es Hardoun almost zero,
not part of Jeita groundwater catchment
ca. 3700 m E of Daraya tunnel (upstream)

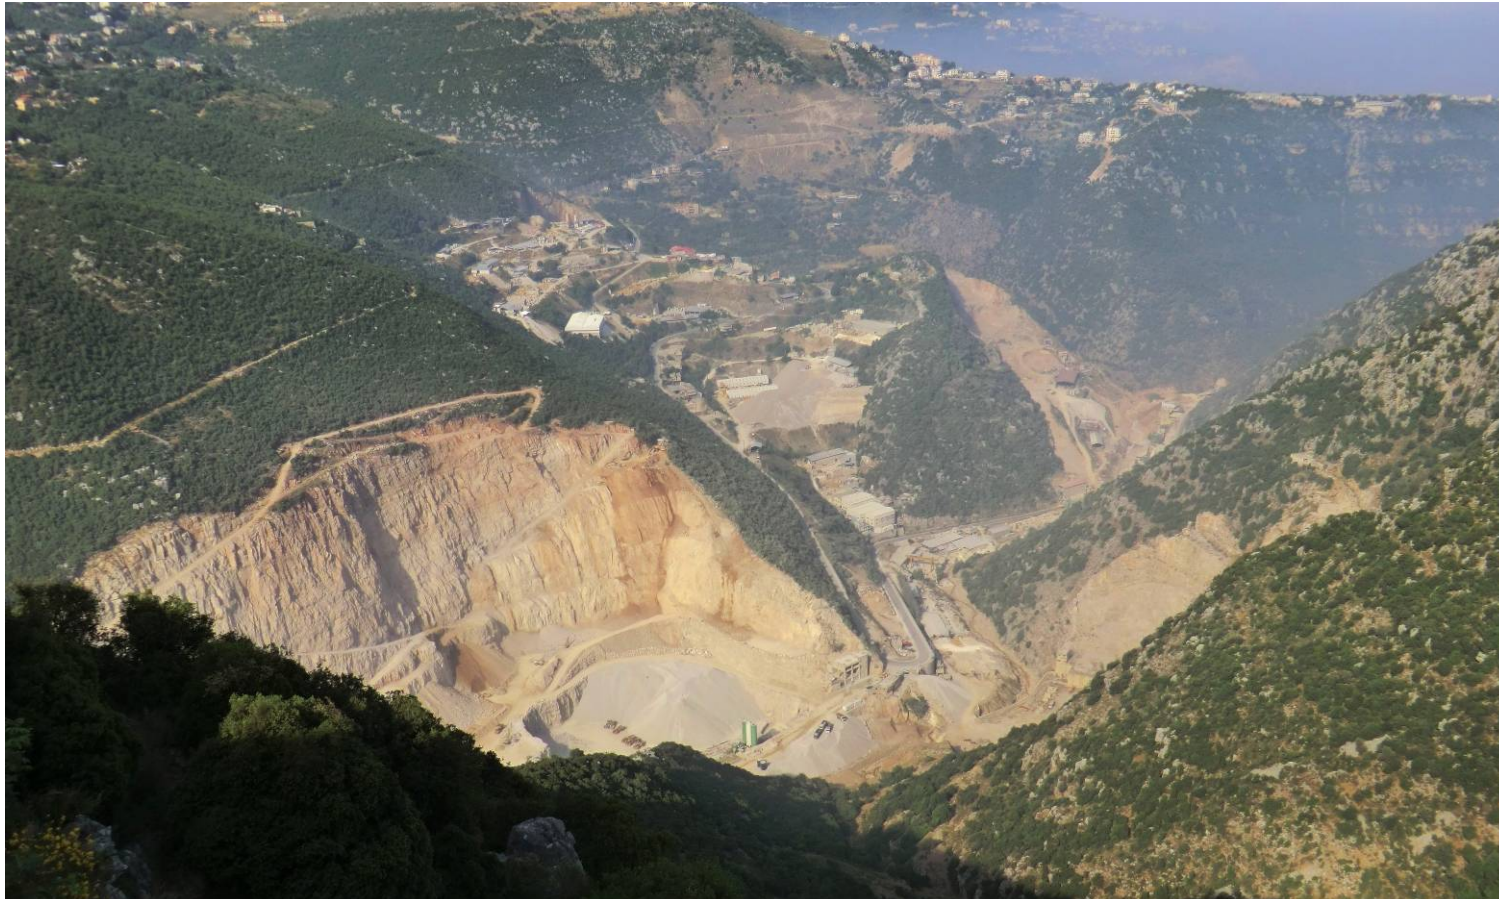
Figure 26: Limestone Quarry for Cement Production (ELKA) in Abou Mizane

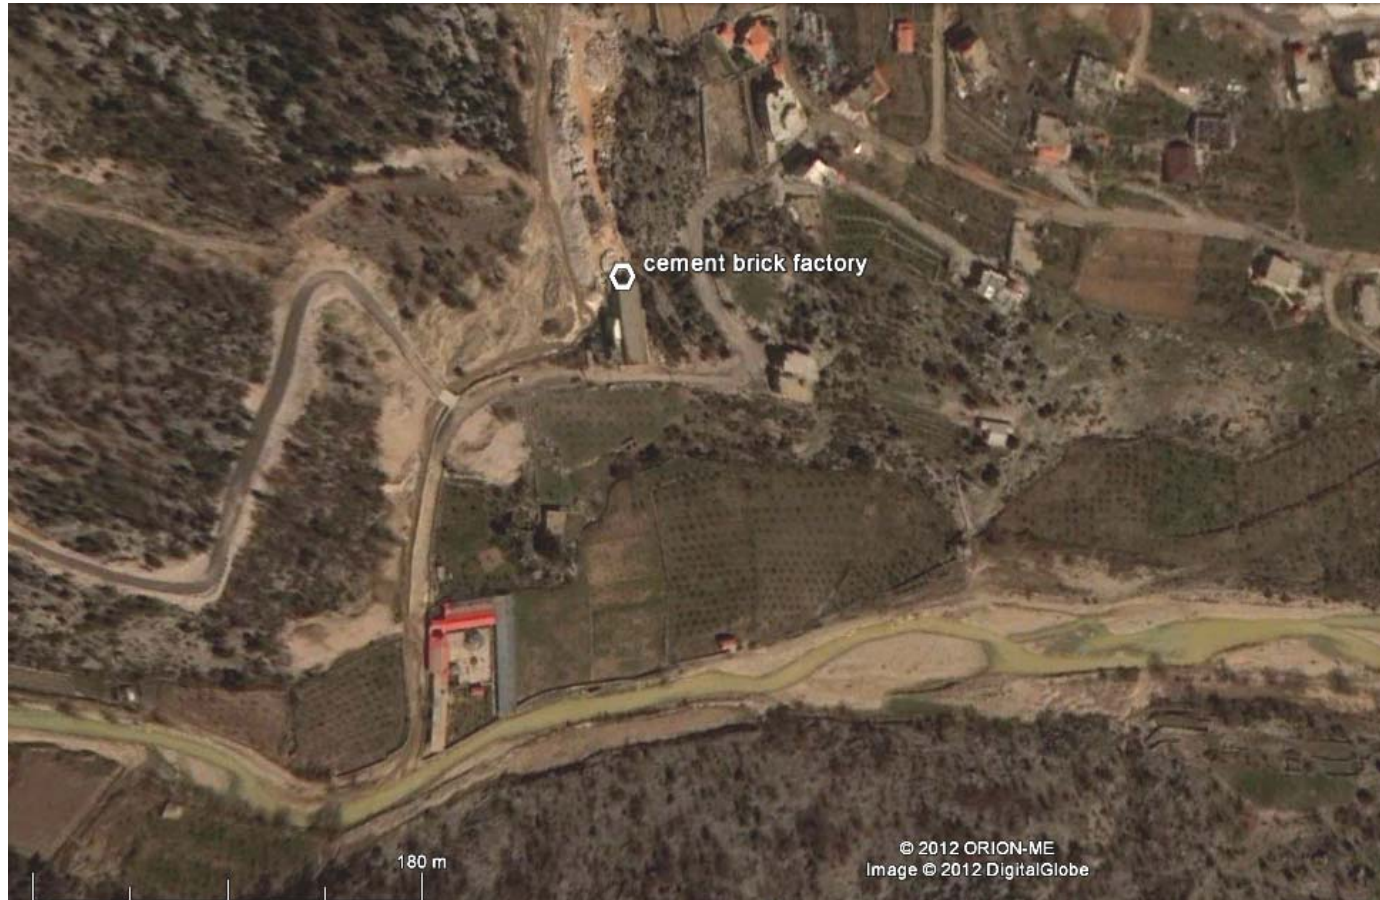
Figure 29: Cement Brick Factory in the Upper Nahr es Salib at Mayrouba

- (8) cement brick fabrication in the upper Nahr es Salib at Mayrouba (Figures 29)
(E 35.779583°, N 34.011525°, ~ 1185 m asl)

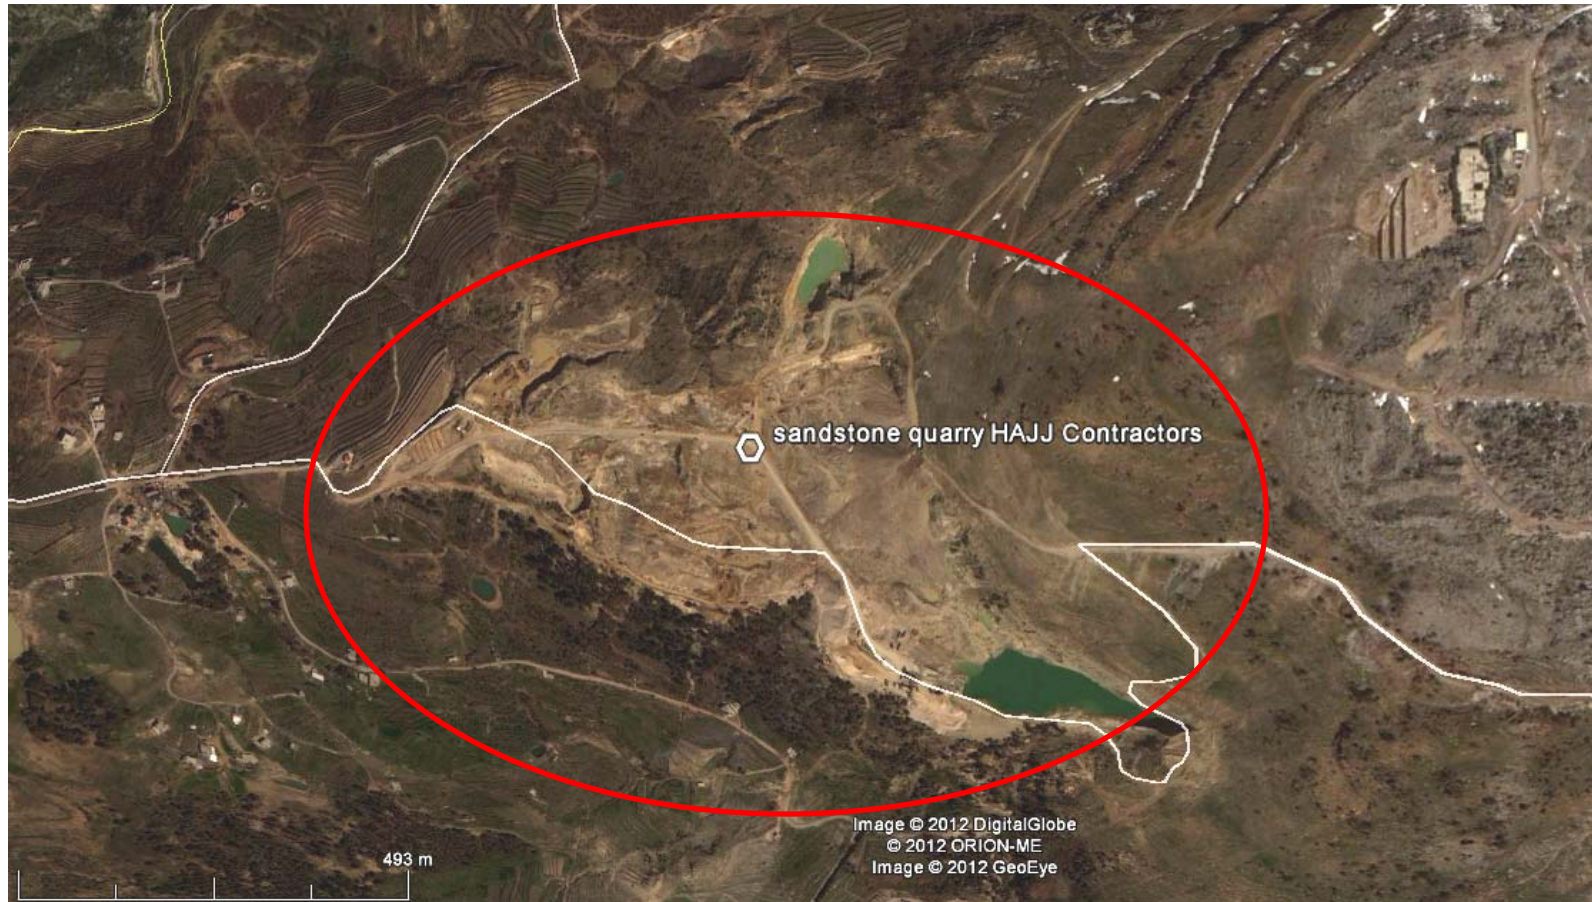
(9) sandstone quarry of HAJJ contractors in Bqaatouta (Figure 30)
(E 35.791707°, N 33.975972°, ~ 1,485 m asl)
large water ponds (total capacity ~ 5,000 m³)
observed sludge discharge into surface water course

Figure 30: Sandstone Quarry of HAJJ Contractors in Bqaatouta

Site (9), very large and active quarry; storage of large amounts of water; discharge of sludge/water mixture observed.

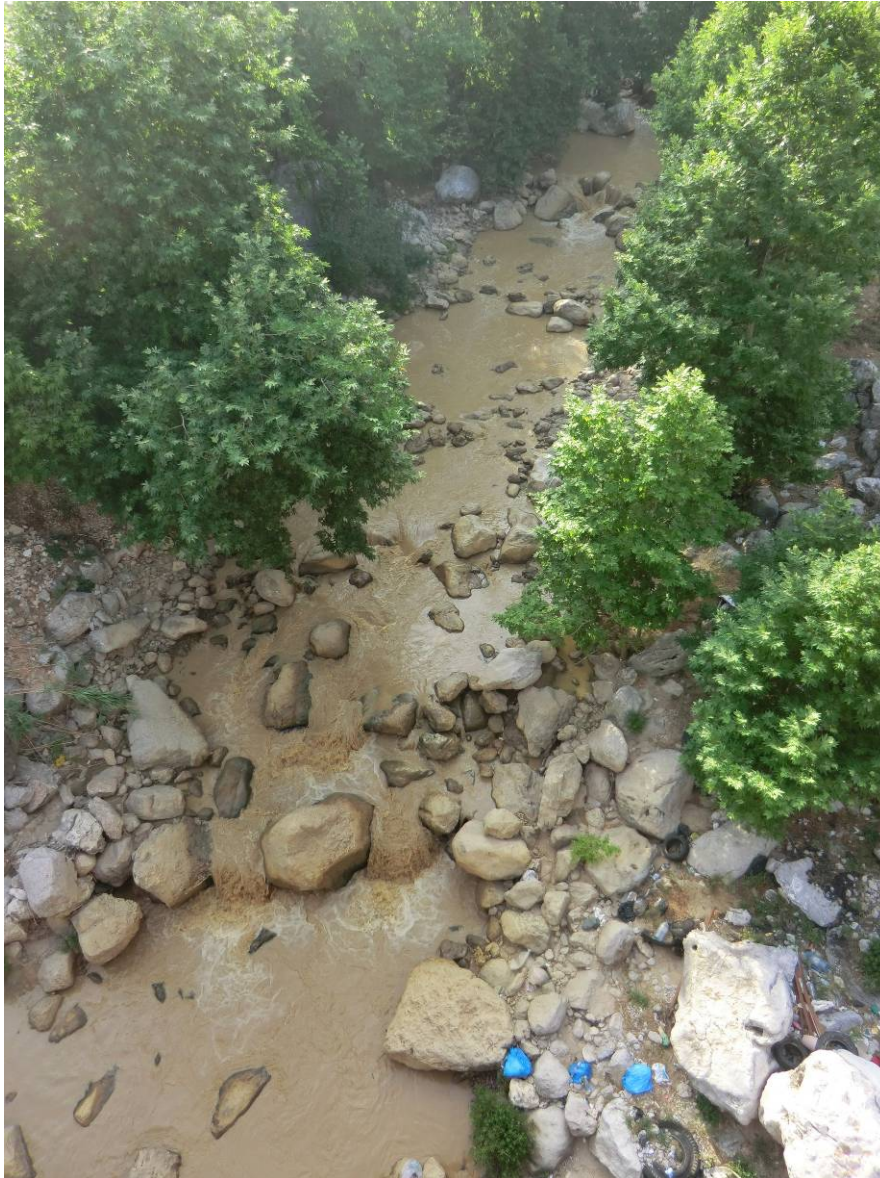
Figure 33: Observed High Turbidity in Lower Nahr es Zirghaya (location 1, looking upstream from bridge)

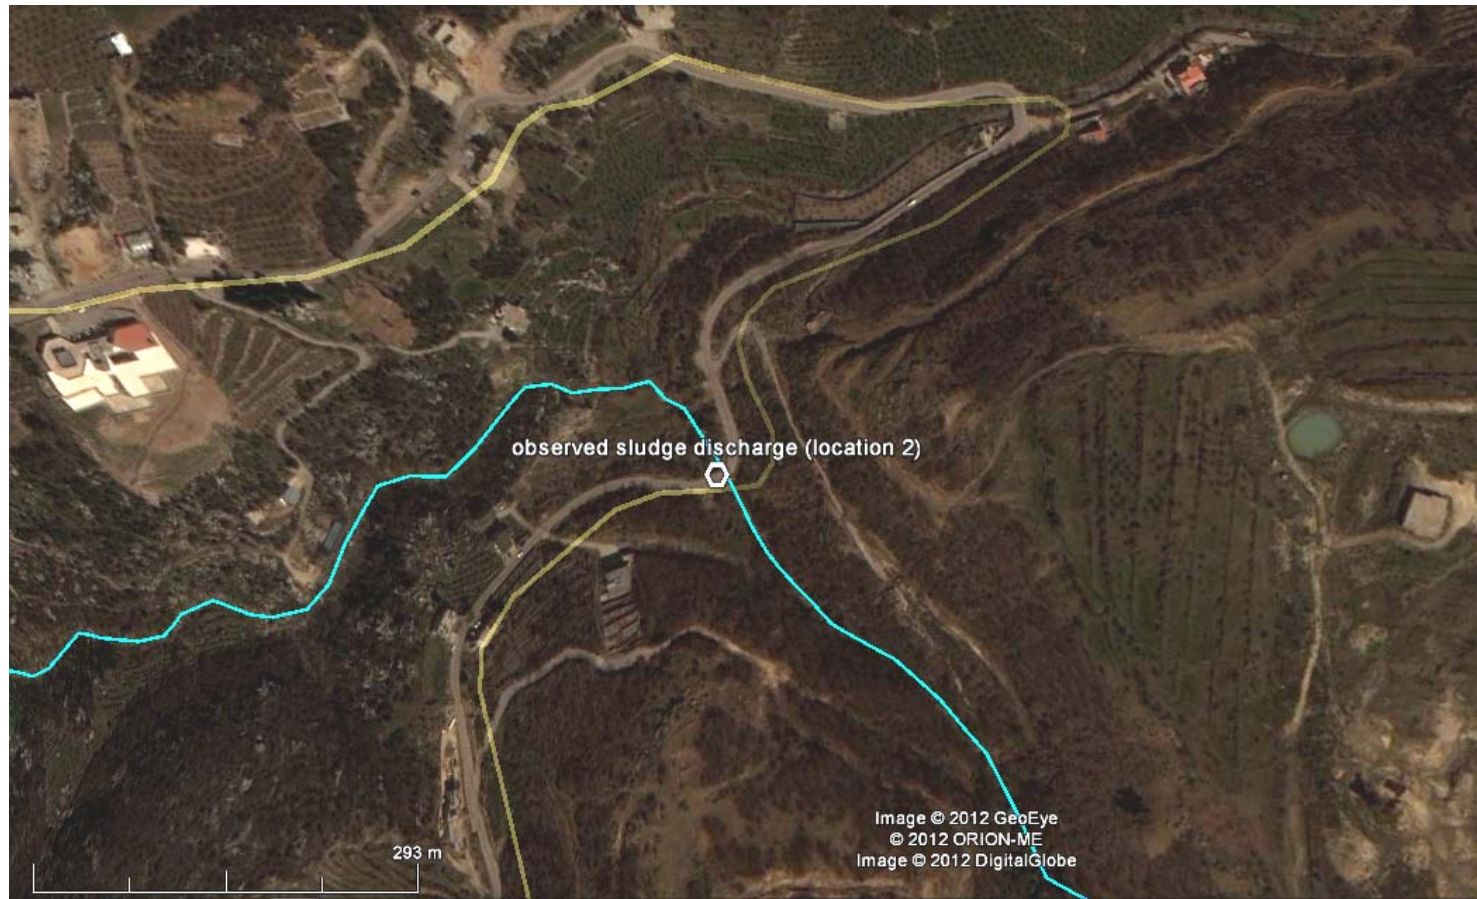
Figure 34: Observed High Turbidity in Upper Nahr es Zirghaya (location 2)

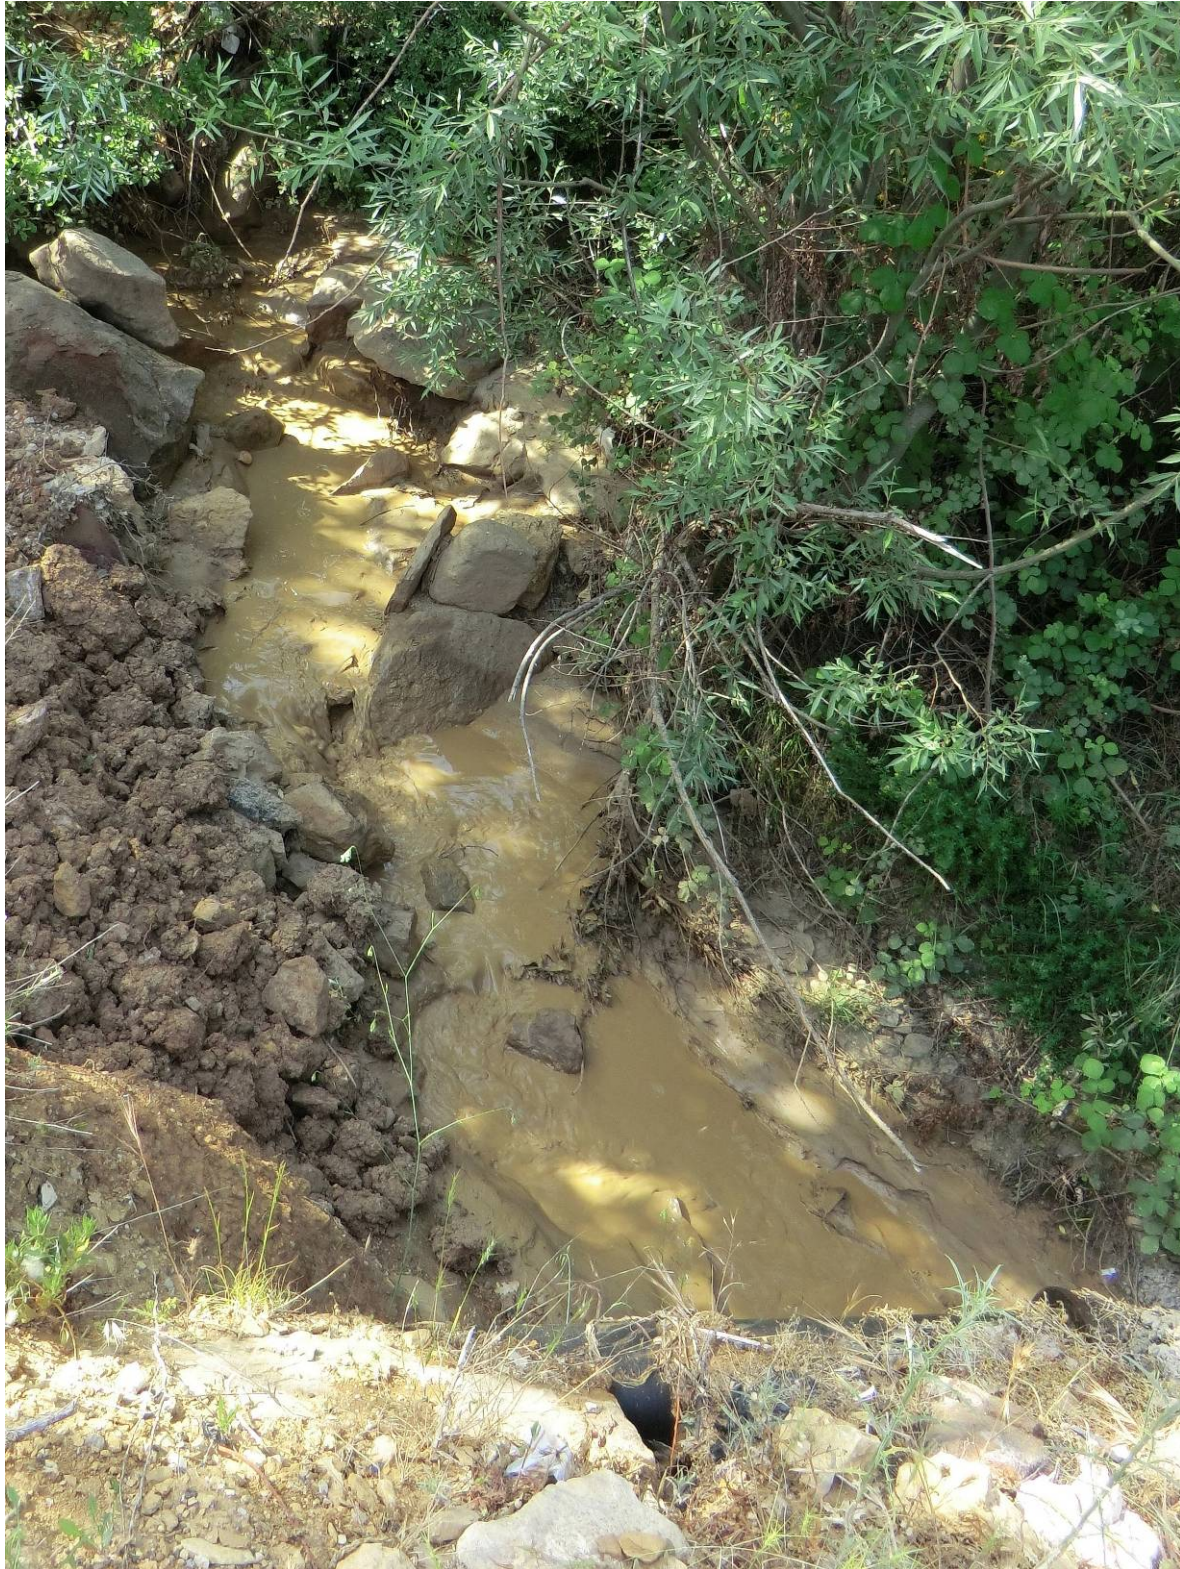
Figure 35: Observed High Turbidity in Upper Nahr es Zirghaya (location 2 near Kfar Debbiane, looking downstream from bridge)
