Protection of Jeita Spring

ADVISORY SERVICE DOCUMENT NO. 2

**Locating the Source of the Turbidity Peaks
Occurring in April - June 2012 in the Dbayeh
Drinking Water Treatment Plant**

**Raifoun
June 2012**

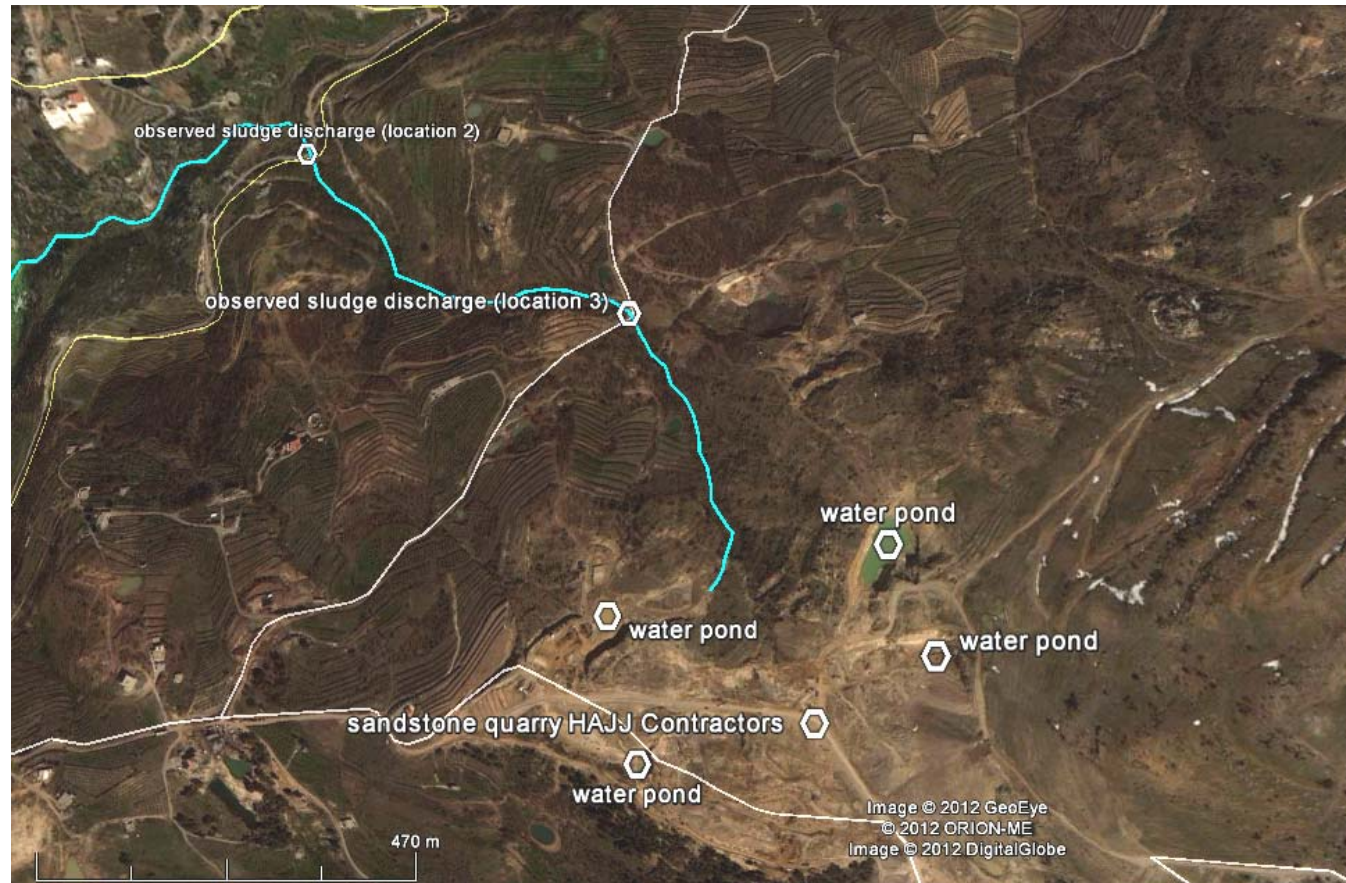
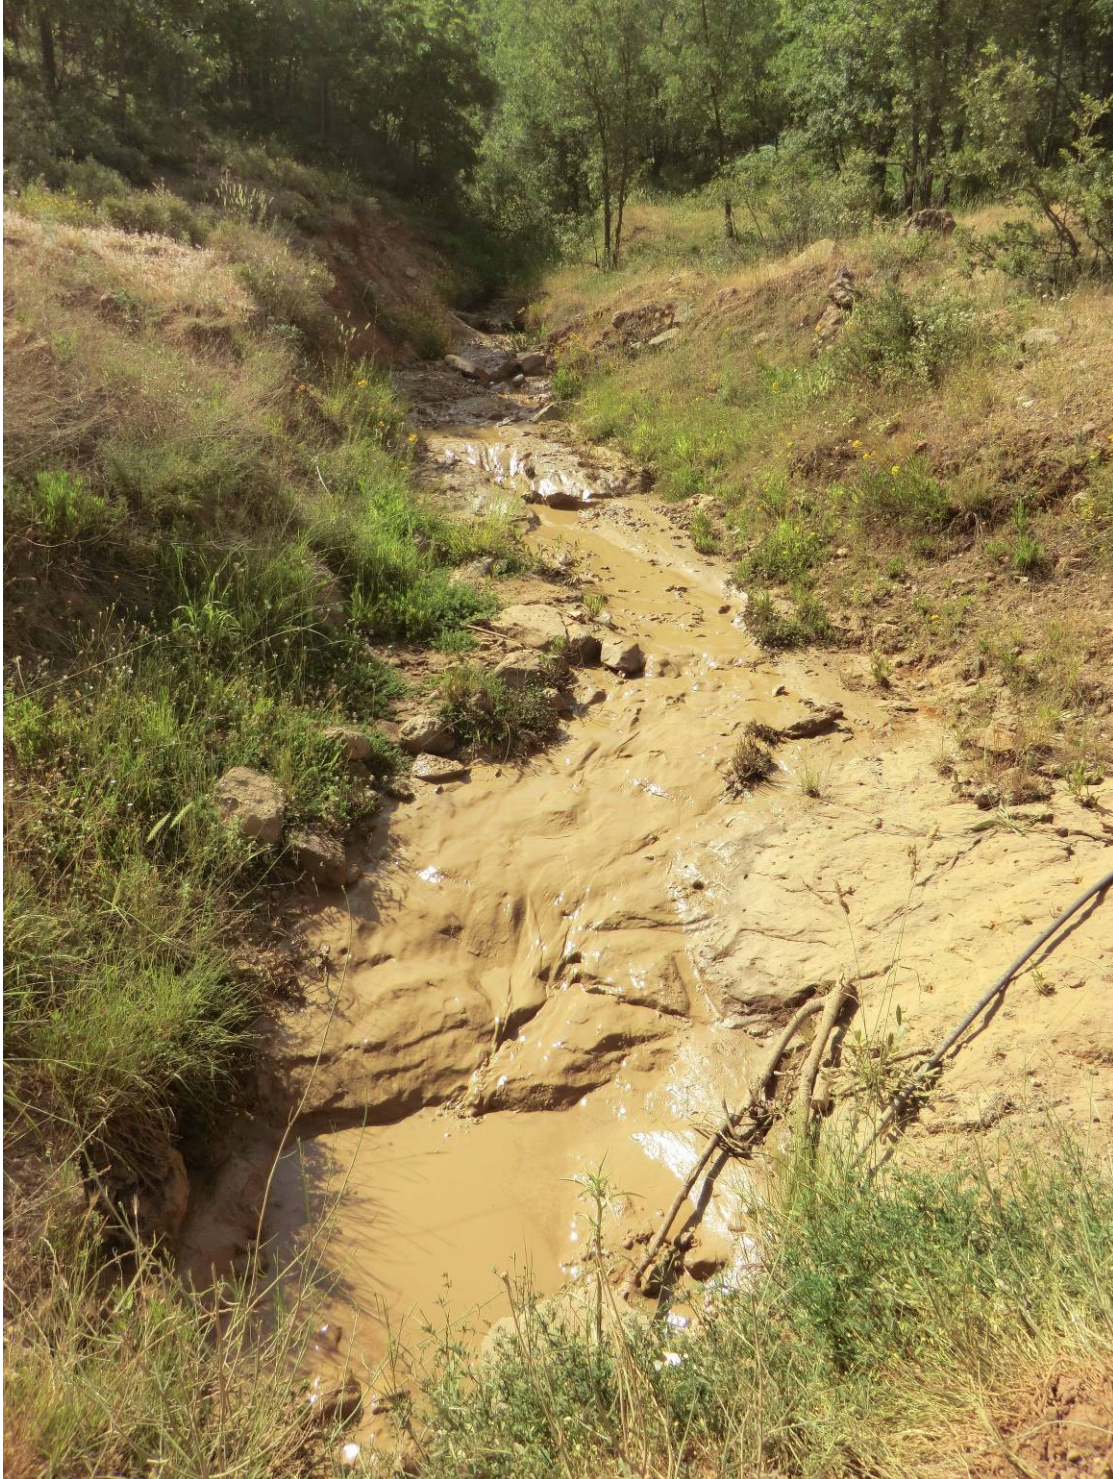
Figure 36: Observed High Turbidity in Upper Nahr es Zirghaya (location 3 NE of Bqaatouta)

Figure 37: Observed High Turbidity in Upper Nahr es Zirghaya (location 3 NE of Bqaatouta, looking upstream from bridge)

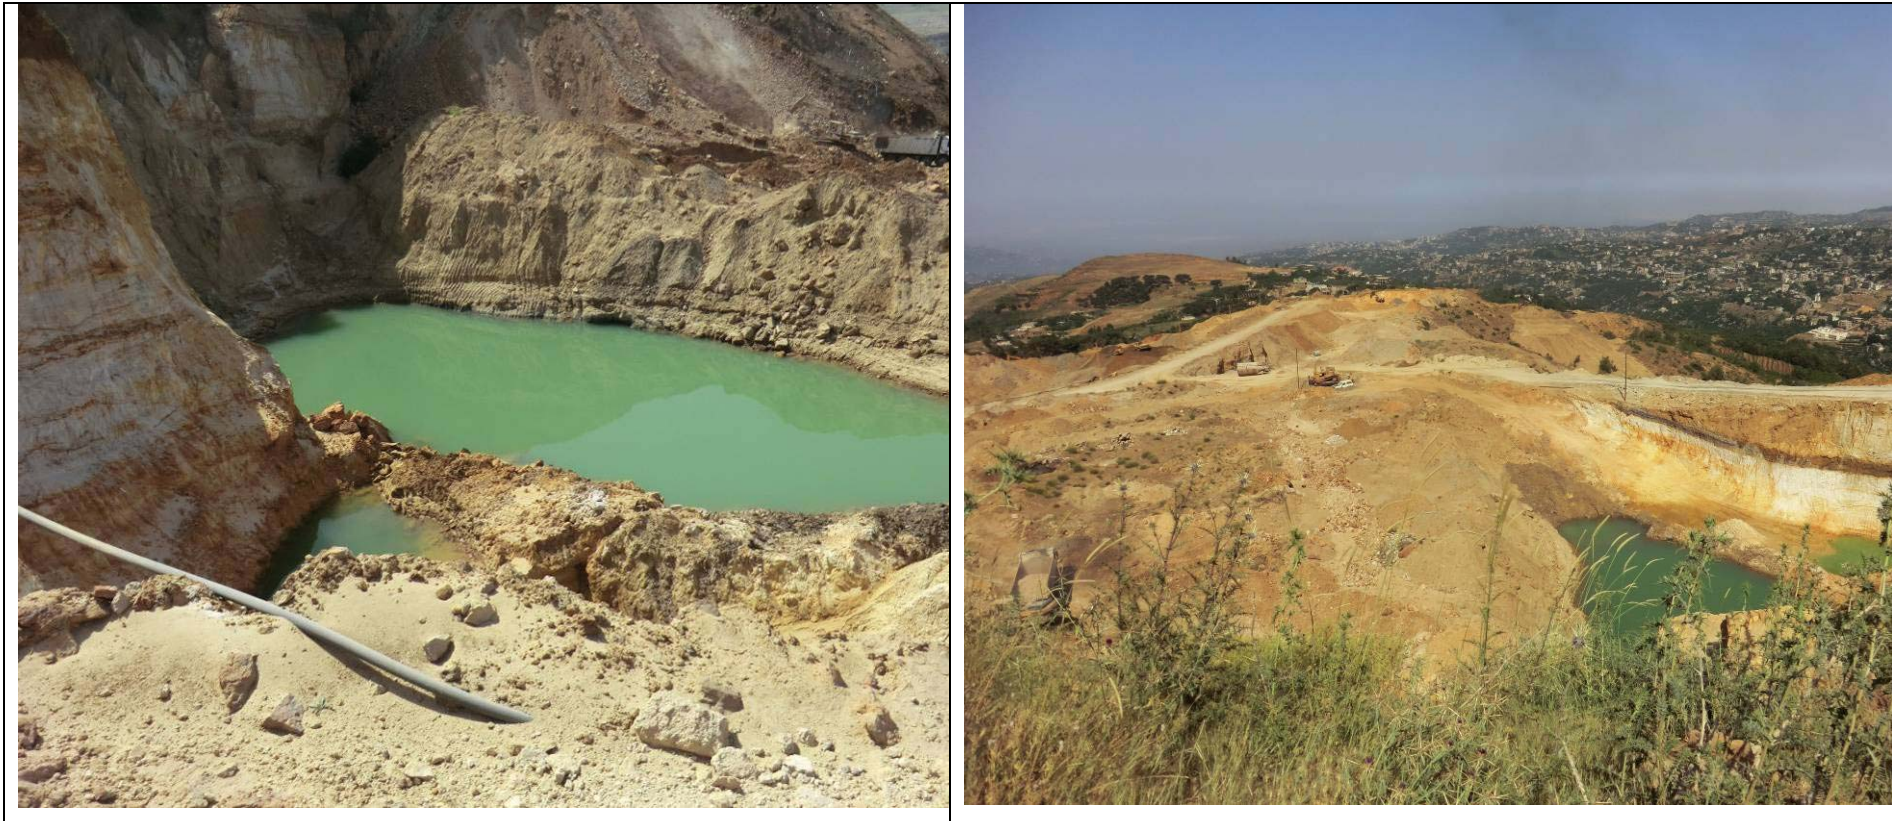
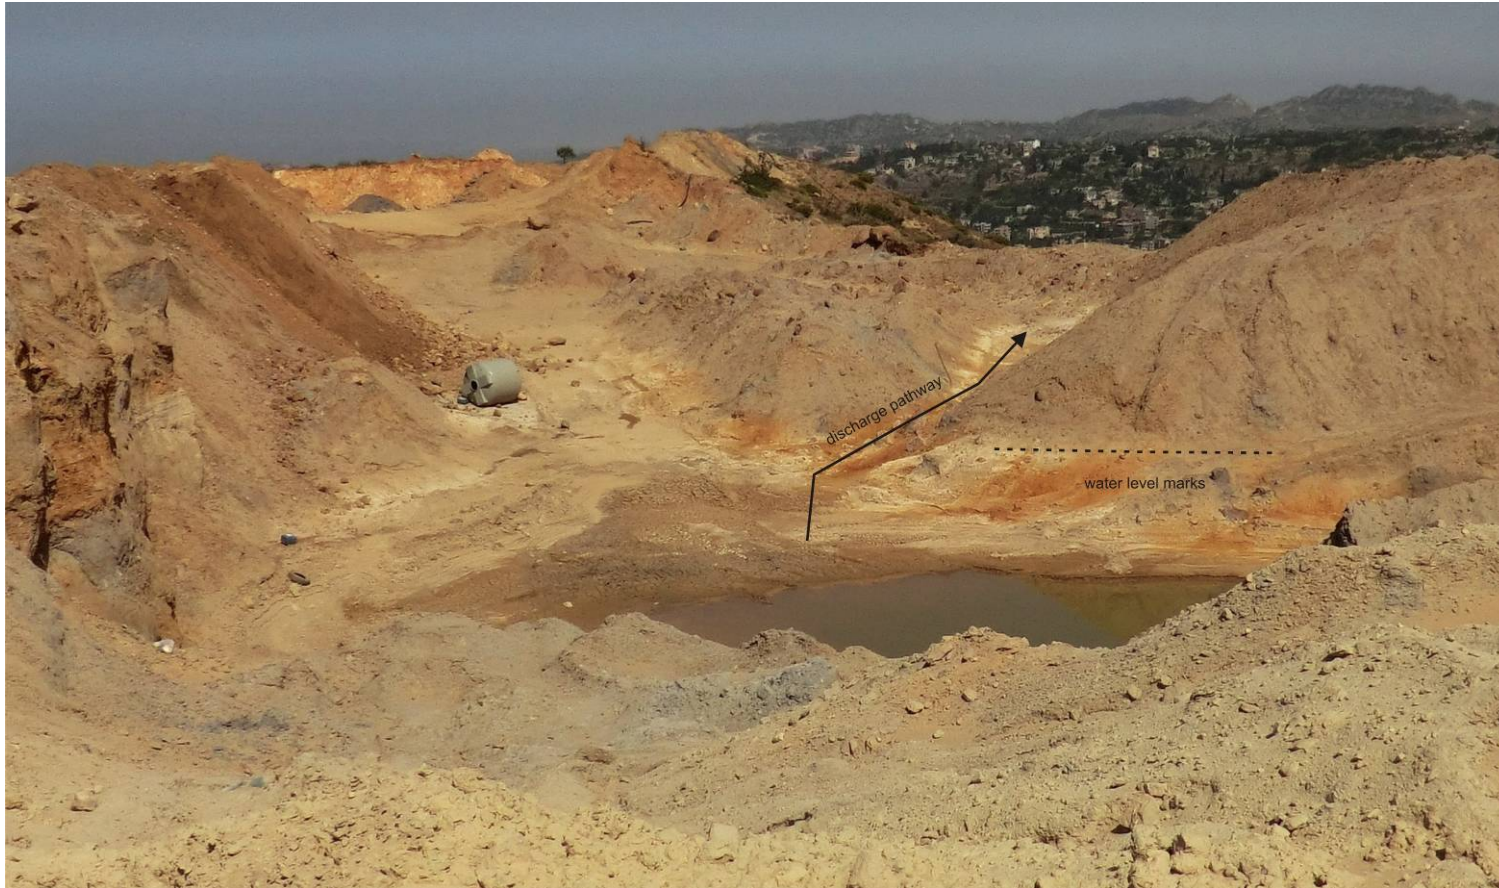
The sandstone quarry has several large water ponds with a combined capacity of at least 5,000 m³ (Figures 36, 37, 38 39, 40). On Sunday, 17 June 2012, some of them were found empty with clear water level marks indicating that they had been containing water shortly before (Figures 38, 39). Also the pond shown in Figure 39 clearly functions as a sediment flushing facility. The Google Earth images show that sediment flushing from ponds at the HAJJ Contractors sandstone quarry must have been practiced at least since the year 2003.

Figure 38: Water Ponds in Sandstone Quarry of HAJJ Contractors in Bqaatouta

Figure 39: Flushed Water Ponds in Sandstone Quarry of HAJJ Contractors in Bqaatouta

Figure 40: Flushed Water Pond in Sandstone Quarry of HAJJ Contractors in Bqaatouta

The Lebanese Government is well advised to introduce an environmental police, such as introduced and efficiently working in Jordan since 2006. Only a well trained and equipped police force will be able to stop a further deterioration of the environment and the precious water resources of Lebanon.

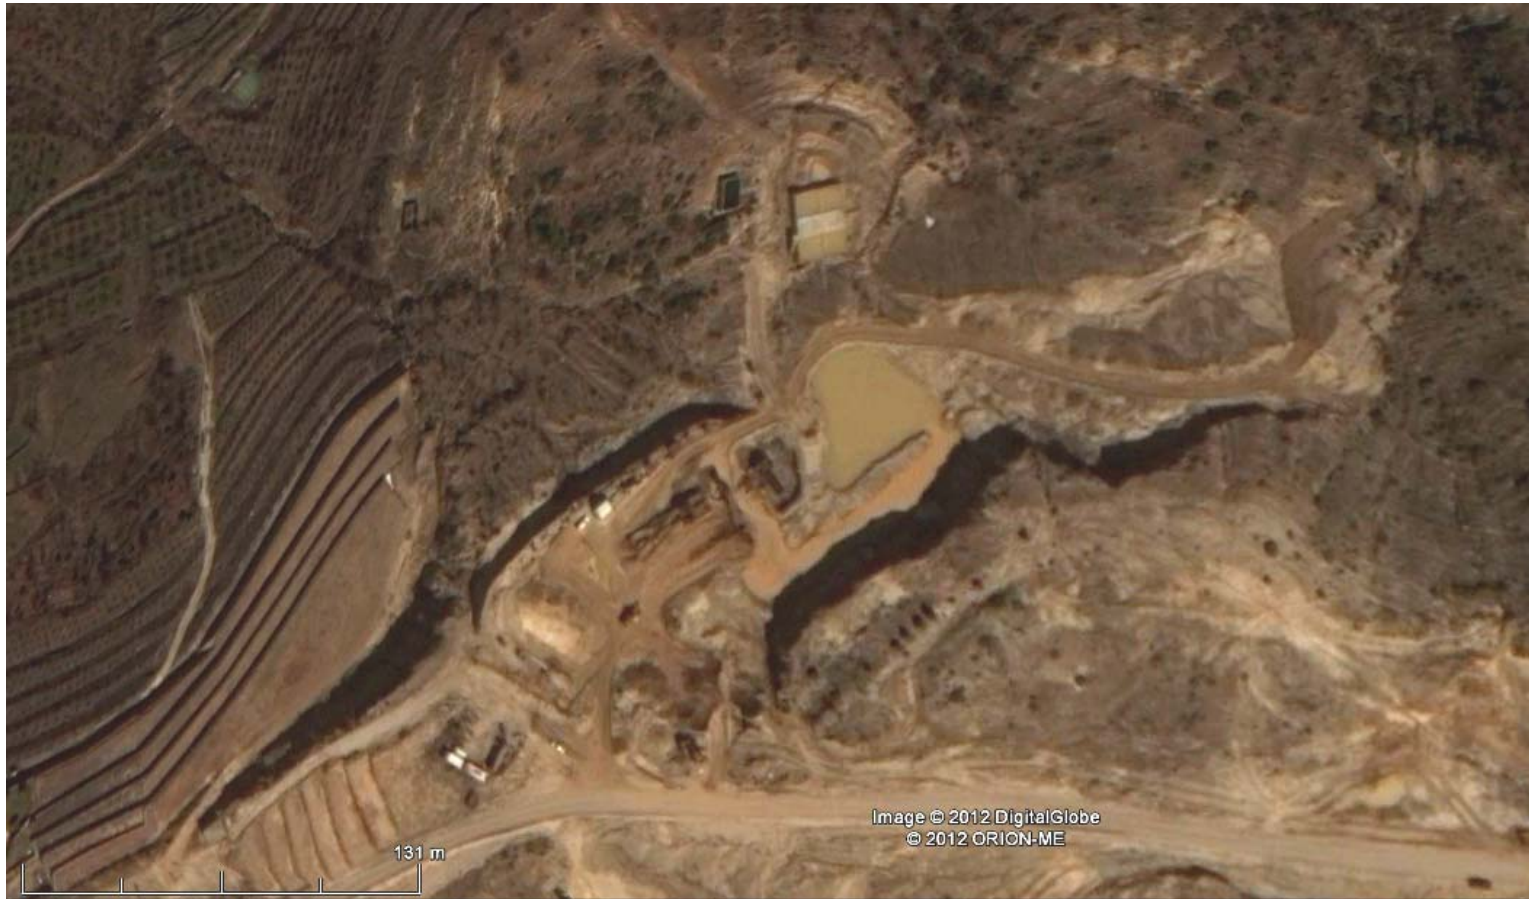
Figure 41: Water Pond used for Sand Washing and Flushing of Fine Material in Sandstone Quarry of HAJJ Contractors/Bqaatouta
